Manhole Inspection Summary

Manhole # S19I1_030MH

Insp Date: **4/22/08 8:55 AM**

Location Address: **3011 lorena av**

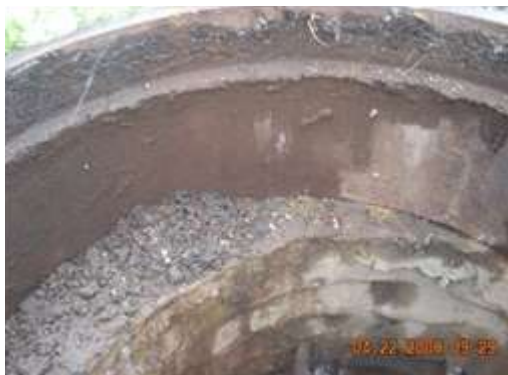
Misc. Defect 4

inflow evidence

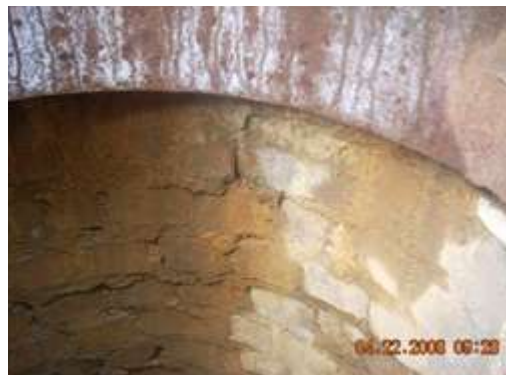
Defect 3

Infiltration: ☐ None ☒ **Joint** ☐ Cracks ☐ Mortar ☐ Roots ☐ Wall

infiltration @ corbel/frame joint

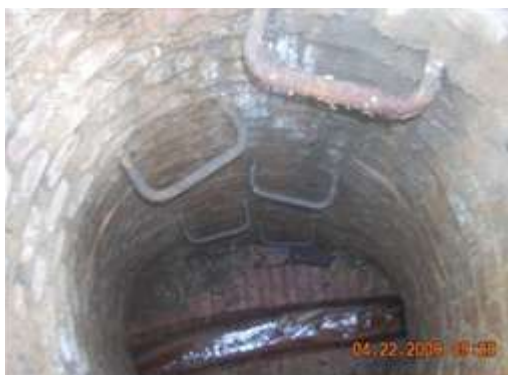
Defect 2

Steps Count: **5** Missing: **0** ☒ **Corroded**

corroded top step

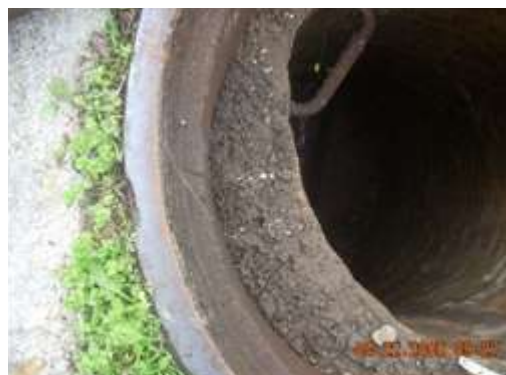
Defect 1

Frame Offset: **4** (in.) Condition: ☒ Sound ☐ Cracked ☐ Leaks

frame offset

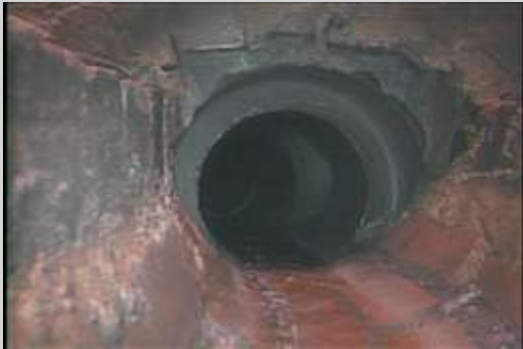
12 O'Clock Outflow

8 in. Circular Gravity Sewer
Pipe Out @ 12 O'Clock

Pipe Height: **7.2** (in.) Rod and Bar (Angled)
Pipe Material: **Clay** ☐ Pipe Lined
Invert Depth: **9.94** (ft.) Flow Characteristics: **Slow**
Deposits: ☒ None ☐ Mud ☐ Sludge ☐ Debris ☐ Grease
Silt Depth: **0** (in.) Deposits Extent:
Infiltration: **None** Pipe Seal Cond: **Sound**

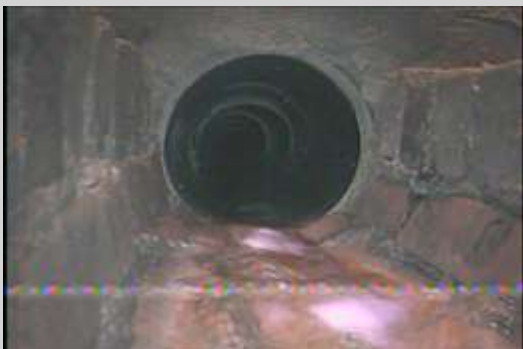
7 O'Clock Inflow

8 in. Circular Gravity Sewer
Pipe In @ 7 O'Clock

Pipe Height: **8.4** (in.) Rod and Bar (Angled)
Pipe Material: **Clay** ☐ Pipe Lined
Invert Depth: **9.82** (ft.) Flow Characteristics: **Slow**
Deposits: ☒ None ☐ Mud ☐ Sludge ☐ Debris ☐ Grease
Silt Depth: **0** (in.) Deposits Extent:
Infiltration: **None** Pipe Seal Cond: **Sound**
